Replacement of floors in cabins after water leak on a platform in the North Sea

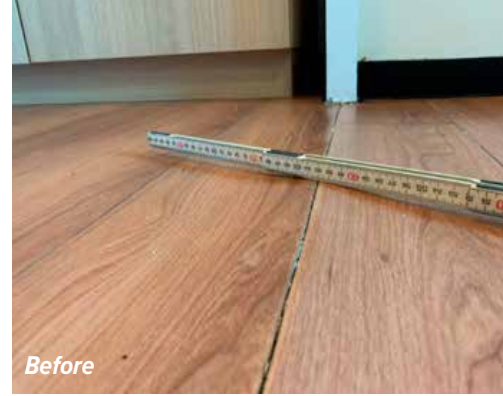
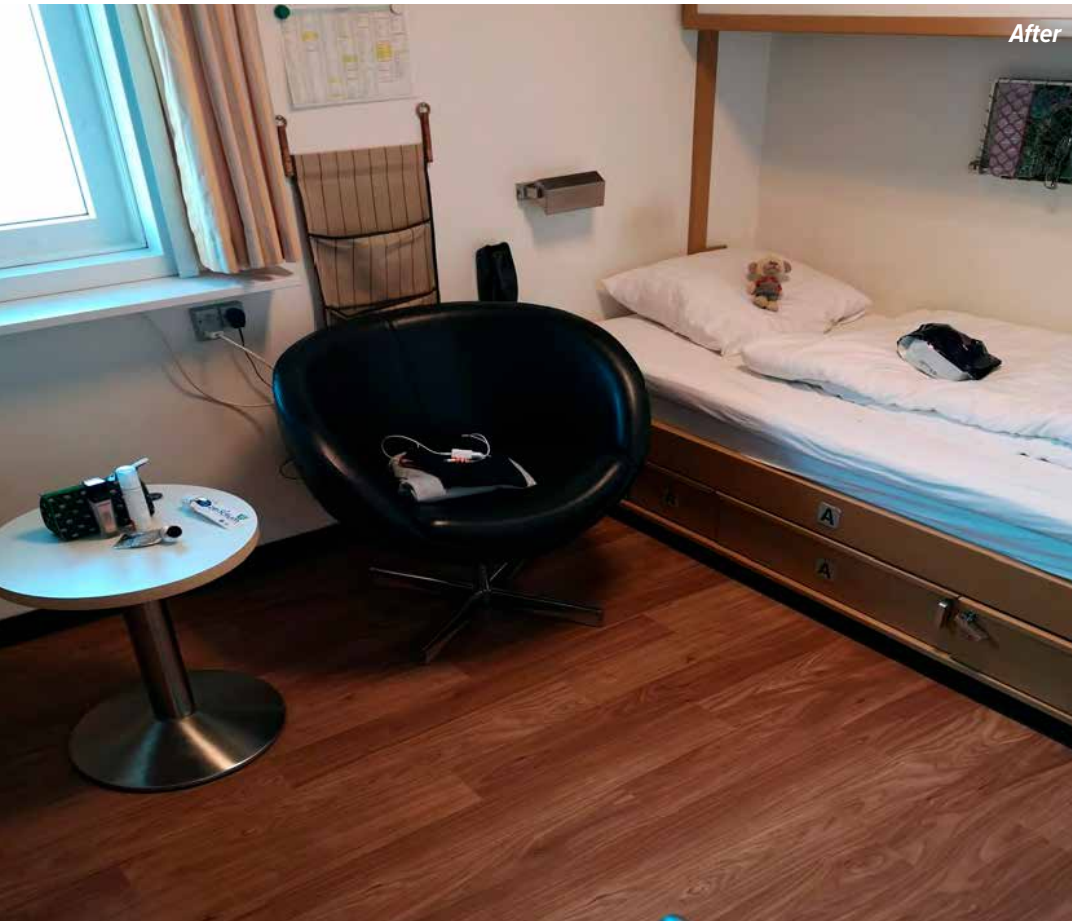
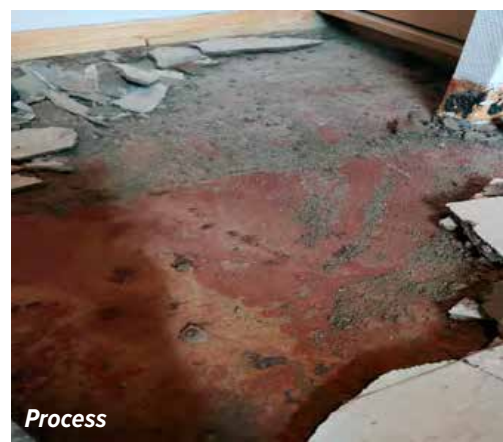
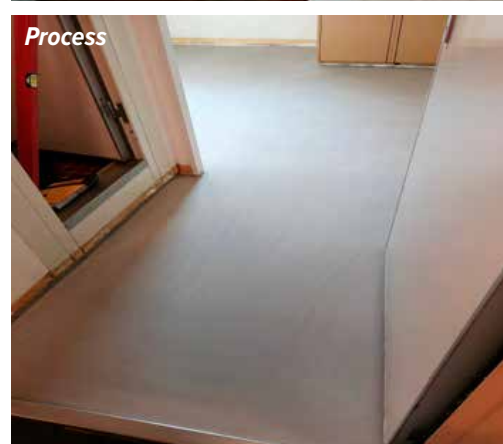
A previous water leak has released the floor several places and resulted in rust in subfloor in two cabins on a platform in the North Sea. Our job was offshore inspection and installation of new floors.

- Technical inspection; offshore survey to clarify the floor condition after water leak including mould test etc.
- Project preparation; work prepare, permit preparation, purchasing and packing materials and tools.
- Project execution offshore;
 - Project management during project
 - Remove furnitures and demold existing floors
 - Grind and prime steel floor
 - Installatin of new subfloors and Amtico top floors.
 - Permit
 - Daily report to customer
- Final documentation and project close-out
